Vietnam: Environmental Remediation of Dioxin Contamination at Danang Airport

Progress Report: June 1, 2013 to June 30, 2013

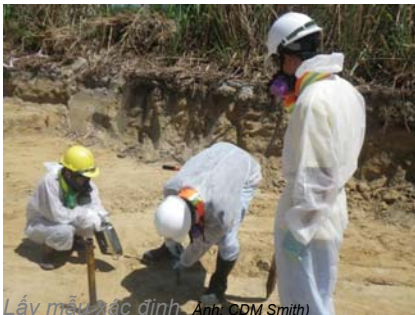
Các nhà thầu của USAID tiếp tục quan trắc, kiểm tra và thử nghiệm rộng rãi nhằm đảm bảo chất nhiễm bẩn không thoát ra khỏi khu vực dự án, và các hoạt động thi công đáp ứng tiêu chí thiết kế. Ngoài ra, các nhà thầu của USAID tiếp tục lấy mẫu đất xác định từ chu vi và đáy khu vực đào xúc nhằm đảm bảo đã đào xúc toàn bộ chất nhiễm bẩn. Mọi công việc lấy mẫu xác định được thực hiện trong sự phối hợp chặt chẽ với Bộ Tư lệnh Hóa học thuộc Bộ Quốc phòng Việt Nam và Trung tâm Nhiệt đới Việt-Nga.

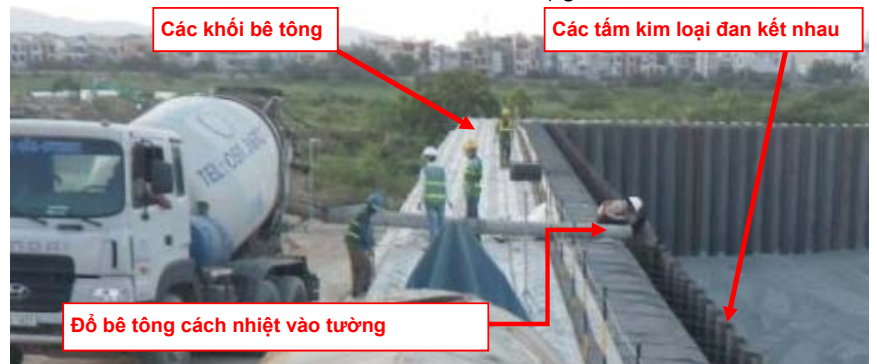
Các tường bên của kết cấu móng (gồm các khối bê tông, bê tông cách nhiệt và các tấm kim loại đan kết nhau – xem ảnh dưới) gần được hoàn tất.
